Contract #: 04-0120F4Cty: SF/ALA Rte: 80 PM: 13.2/13.9File #: 69.28**WELDING INSPECTION REPORT****Resident Engineer:**Siegenthaler, Peter**Address:** 333 Burma Road**City:** Oakland, CA 94607**Report No:** WIR-023859**Date Inspected:** 18-May-2011**Project Name:** SAS Superstructure**OSM Arrival Time:** 700**Prime Contractor:** American Bridge/Fluor Enterprises, a JV**OSM Departure Time:** 1900**Contractor:** Zhenhua Port Machinery Company, Ltd (ZPMC), Changxing Island **Location:** Shanghai, China**CWI Name:** Mr. An Qing Xiang**CWI Present:** Yes No**Inspected CWI report:** Yes No N/A**Rod Oven in Use:** Yes No N/A**Electrode to specification:** Yes No N/A**Weld Procedures Followed:** Yes No N/A**Qualified Welders:** Yes No N/A**Verified Joint Fit-up:** Yes No N/A**Approved Drawings:** Yes No N/A**Approved WPS:** Yes No N/A**Delayed / Cancelled:** Yes No N/A**Bridge No:** 34-0006**Component:** Orthotropic Box Girder(OBG)**Summary of Items Observed:**

OBG Trial Assembly open yard.

Segment:13AW

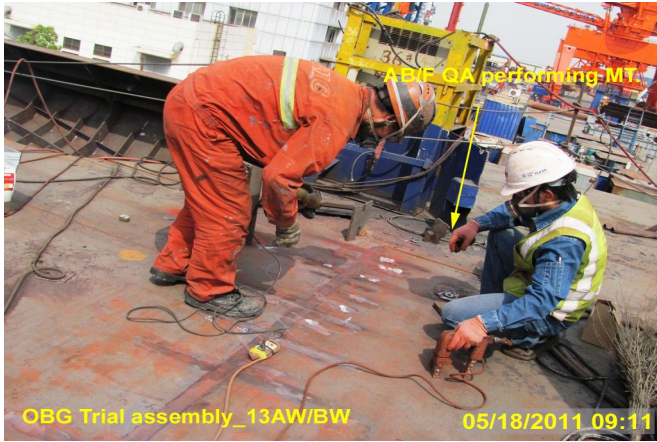
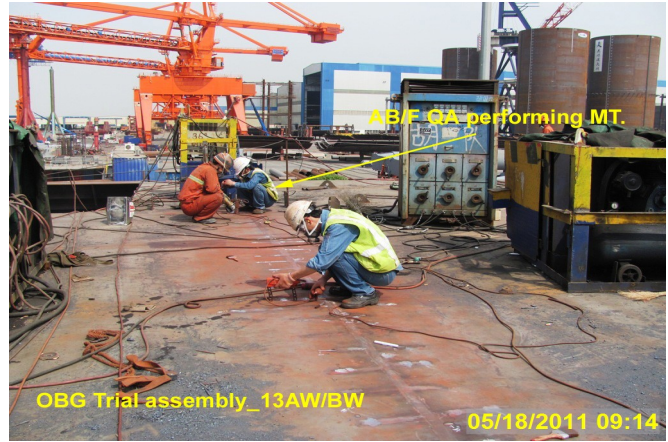
AB/F QA Inspector's performing Magnetic Particle Testing for the deck panel base metal repaired areas adjacent to the splice weld joint. See attached photos for further details.
